REVEGETATION AND HABITAT REHABILITATION PLAN FOR THE 132KV OVERHEAD POWERLINE BETWEEN EXISTING BON ESPIRANGE AND KOMSBERG SUBSTATIONS IN THE WESTERN AND NORTHERN CAPE PROVINCES

Kuduskop Wind Farm (Pty) Ltd

May 2025

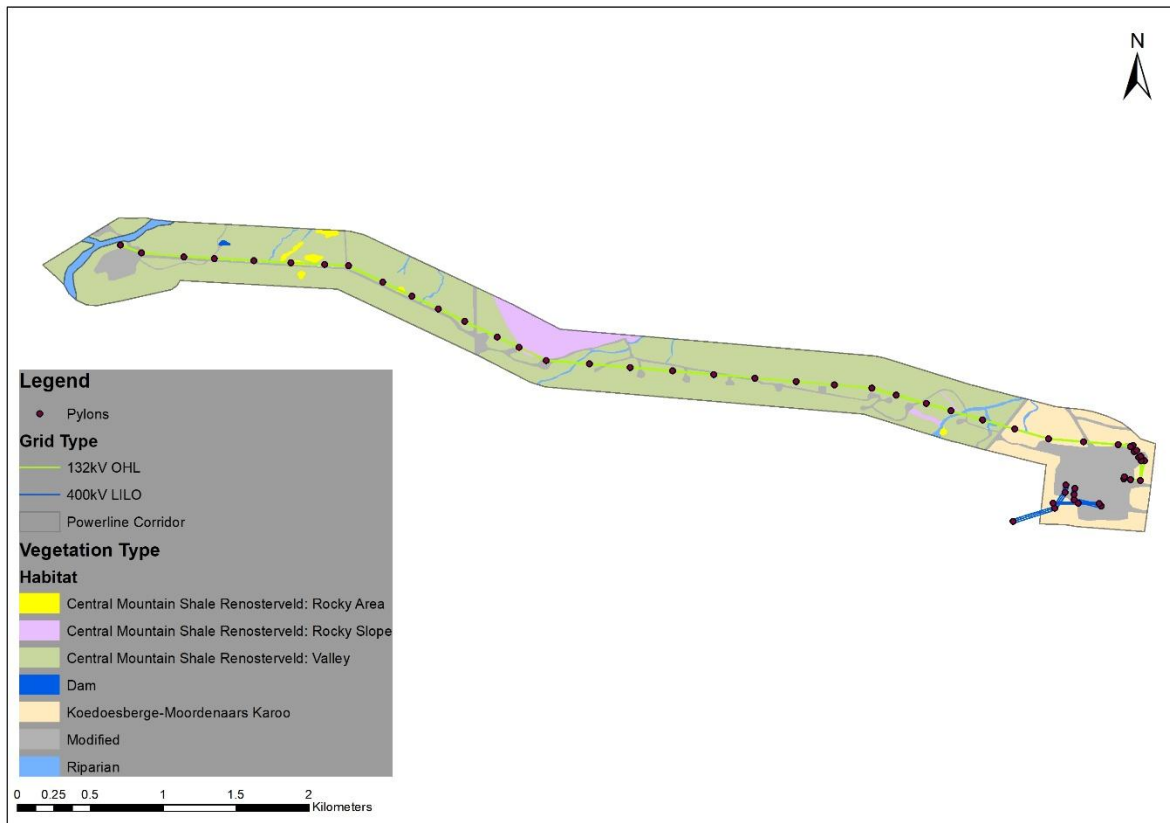
Figure 2.1: Vegetation map of the project area

The project area occurs within two national vegetation types; Koedoesberge-Moordenaars Karoo and Central Mountain Shale Renosterveld at the transition zone between the Fynbos Biome and Succulent Karoo Biome. Although neither vegetation type is protected, both are listed as least concern with 99% and 97% of their remaining extent intact (DFFE, 2022).

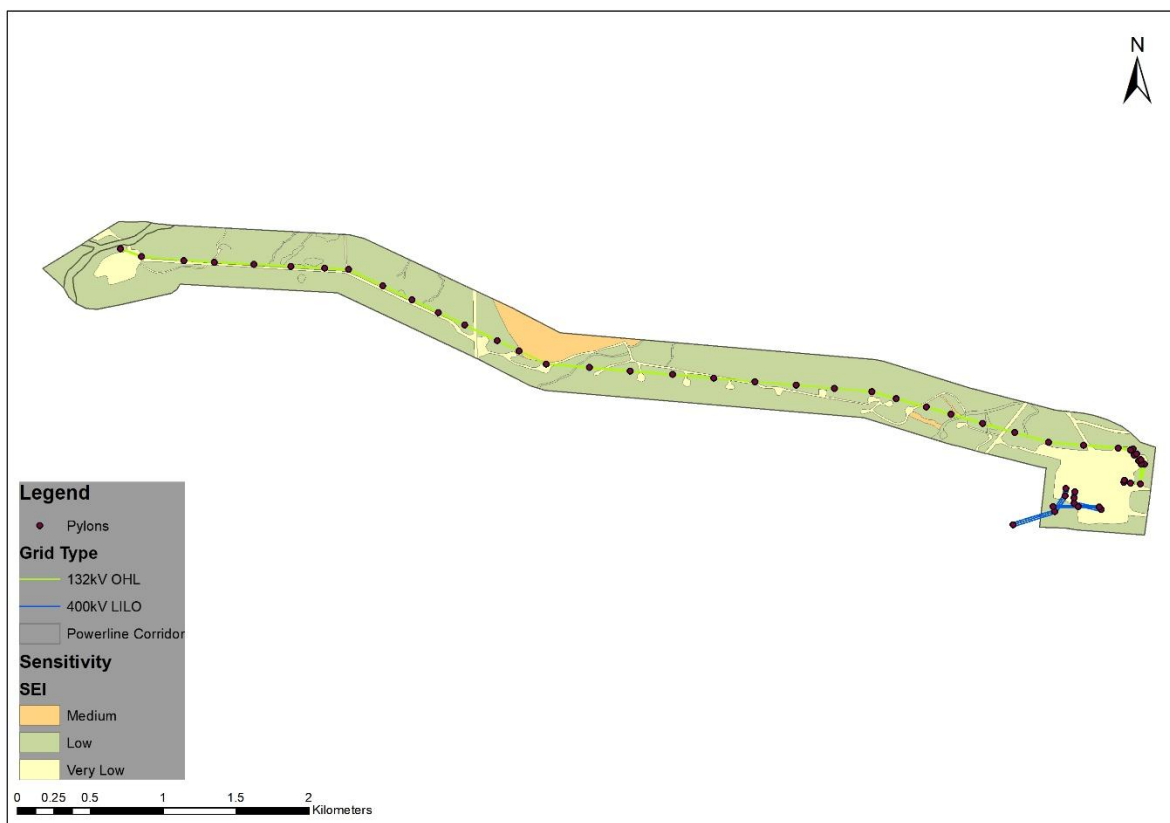
Figure 2.2: Sensitivity map of the project area
